Mandatory Structural Inspection (Milestone) Report

Phase 1 Milestone Study Per Florida Statute 553.899 (SB 154)
Half Moon Condominium Association, Inc. (KHOV – Low Rise Buildings)
7070 Half Moon Circle, Hypoluxo, FL 33462

July 9, 2024

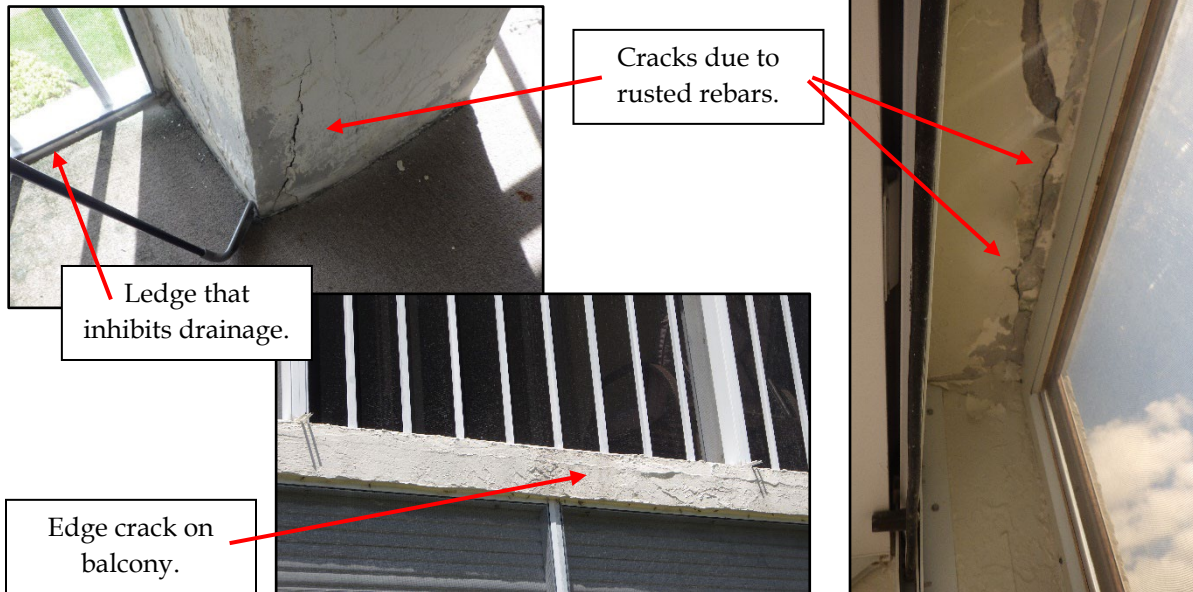
- a. Small areas of cracked concrete were observed along some balcony edges and lower corners of balcony columns. Such areas identified during the Milestone Inspection or through other means should be restored and maintained to minimize conditions that are contributing to rainwater leaking into concrete balconies should be remediated. In general, conditions that trap water (such as the lower rails of balcony screens, can result in water infiltrating areas such as unsealed screws into the concrete). Small drainpipes were installed in many of the balconies, but the inlets of some were blocked.

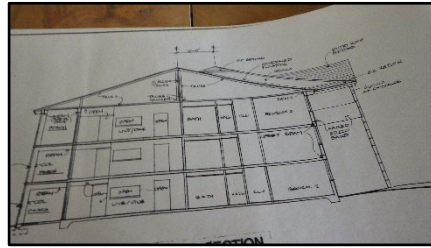
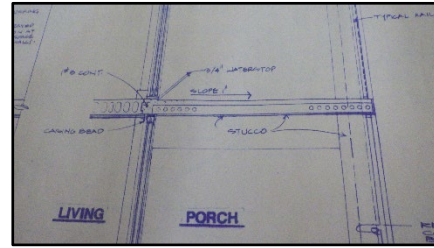
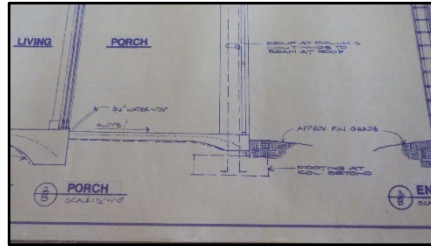
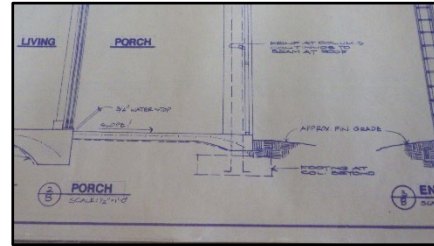
- b. Coverings of balcony floors can contribute to and conceal deterioration of concrete balconies. Removal of carpets, which trap and hold water, is recommended, and avoidance or monitoring and maintenance of balcony tile coverings is recommended. Fluid applied waterproofing membranes, although not as appealing as floor tiles, are generally considered to be the best for above grade balconies, because they do not conceal degradation. Shown below for reference a building plans showing balcony construction. A copy of these plans was held in the office.

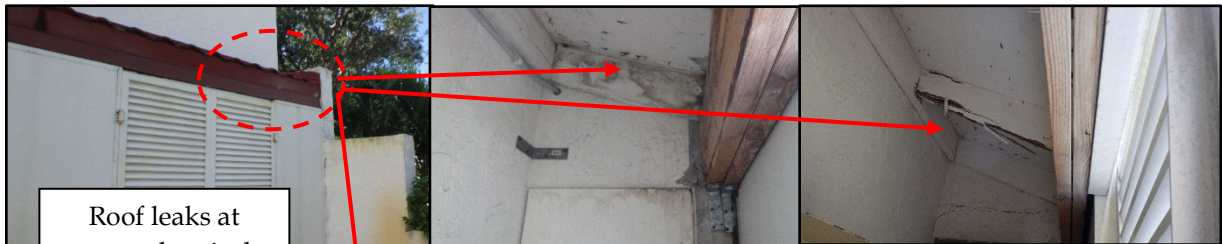
c. Leaks: Within some of the electrical closets, moisture stains, rot, and repairs to small areas of the wood roof framing were observed, typically beneath the right corner when looking into the closet. Appropriate sealing/repairs to the roof/flashing coverings and repairs to damaged framing should be performed to prevent further roof damage and possible damage/dangerous conditions with the electrical systems.

Roof leaks at some electrical closets.

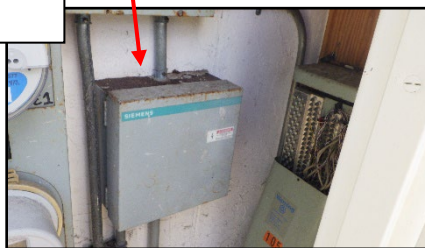
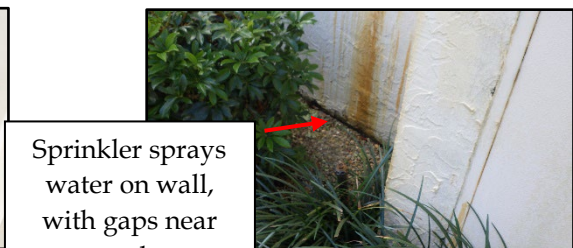
The concrete foundation does not extend significantly above grade, which can result in groundwater and sprinkler leakage through gaps where the wall/foundation interface. Such conditions are difficult to rectify but can be improved by patching gaps with waterproofing and stucco patches, directing sprinklers away from walls, and improving drainage conditions along walls.

Sprinkler sprays water on wall, with gaps near grade.

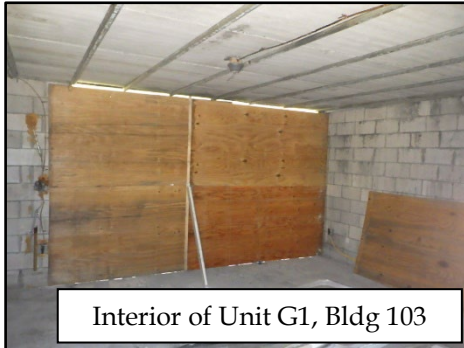
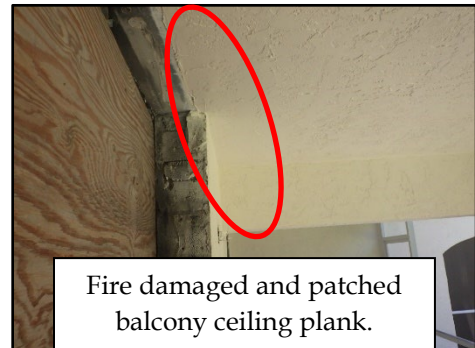
Interior of Unit G1, Bldg 103

A concrete floor plank was reportedly fire-damaged at Unit G1 of Building 103 and was temporarily patched during the April inspection. By the time of the June inspection, the damaged concrete plank had been repaired with an engineered drawing (Mona Ederle, PE, SI) and Permit #24-06-235.

Fire damaged and patched balcony ceiling plank.

Conditions of fire damaged Unit during the April Visit.

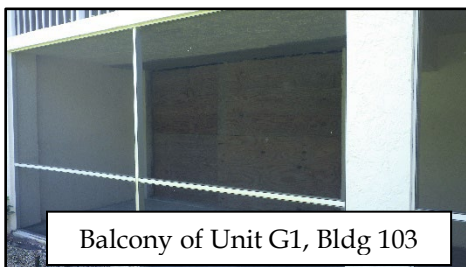
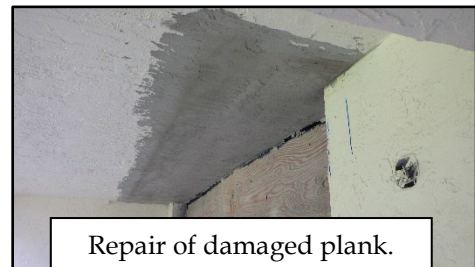
Balcony of Unit G1, Bldg 103

Repair of damaged plank.

Conditions of repaired damage during the June Visit.

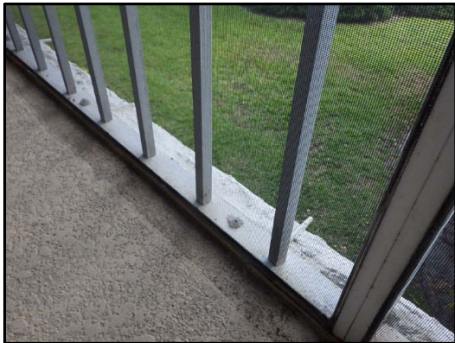
Balcony railing with lower edge screwed into concrete floor.

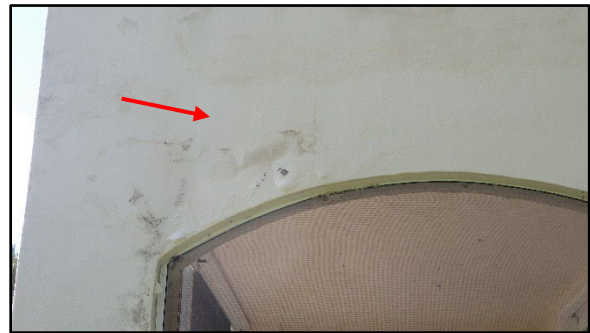
Bubbles behind paint are indications of water intruding the wall above.

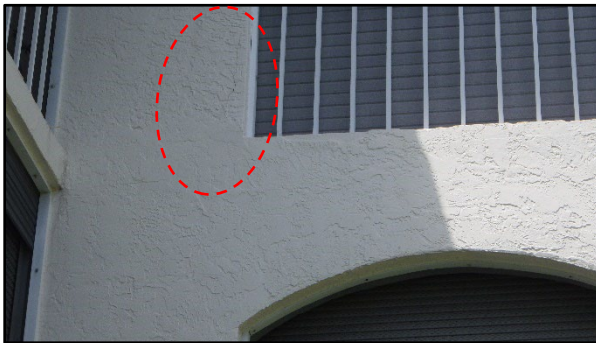
Crack in stucco on exterior of a balcony wall.

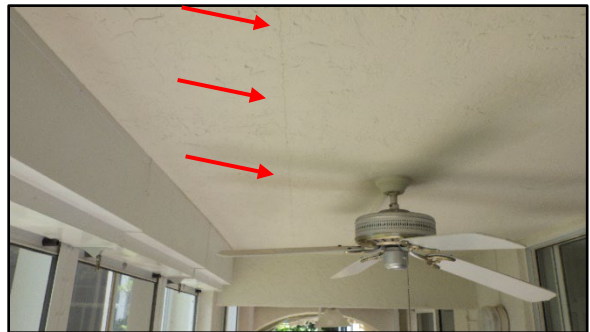
On balcony ceilings were some long, straight, hairline width cracks. These cracks are not indicative of rusty rebars but of differential deflection of concrete planks or trusses (above top floors). These cracks

Hairline crack in ceiling along plank line. Not concerning

are not a structural concern but should be sealed to prevent moisture intrusion that can develop into deterioration.

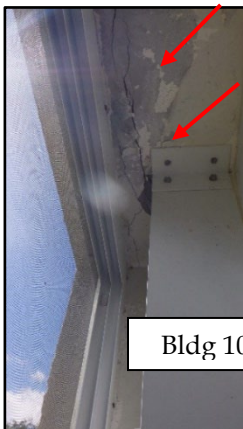
Cracked edge on balcony ceiling.

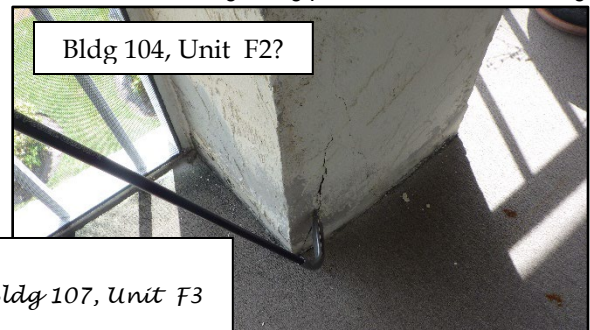
Around a few balconies were observed some cracks and spalls indicative of rusting rebars. These conditions are not dangerous or substantial structural deterioration, but any such areas of cracked and loose concrete should be promptly remediated (loose concrete chipped away, rusted rebar properly repaired, patched, and painted) to prevent spiraling future deterioration.

Cracked/spalled column on balcony.

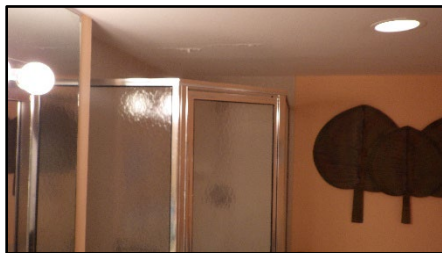
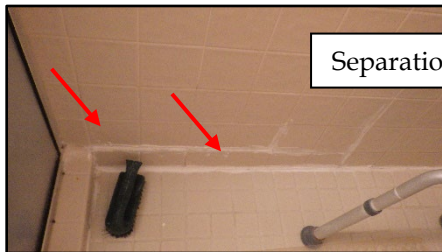
- a. Bldg 106, Unit C2 – Slight separation in vicinity of bathroom were reported by the owner. The Owner also reported that an investigation/repair had been performed by removing the ceiling and a concrete floor plank was found to be misaligned/lifted due to a lump of mortar on top of the masonry support wall (a construction defect). CMSI inspected the surrounding Units 106C1, C3, B2 for similar conditions. No cracks/separations were found in C1 or B2. In C3 small cracks/gaps were found in the tiles of the shower stall, that were consistent with the reported plank condition. The condition is not expected to worsen although the cracks/gaps in both showers should be well sealed, or the shower stalls repaired or rebuilt to prevent water intrusion below.

Separations in Unit C2

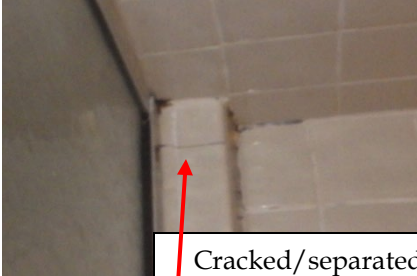
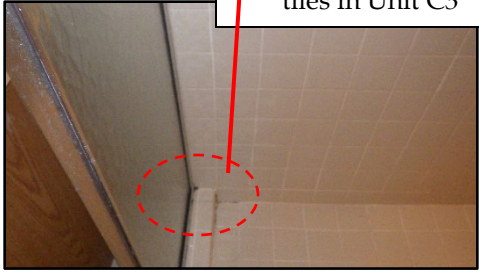
Cracked/separated tiles in Unit C3

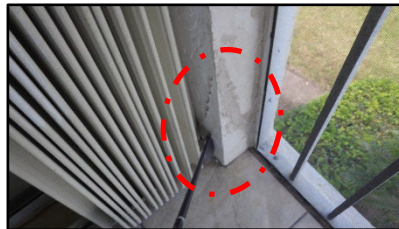
Cracked column on balcony.

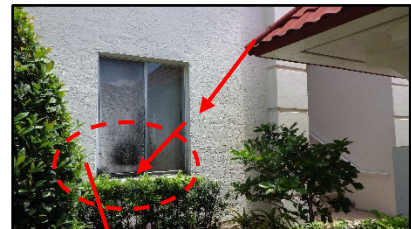
Roof runoff flows onto window.

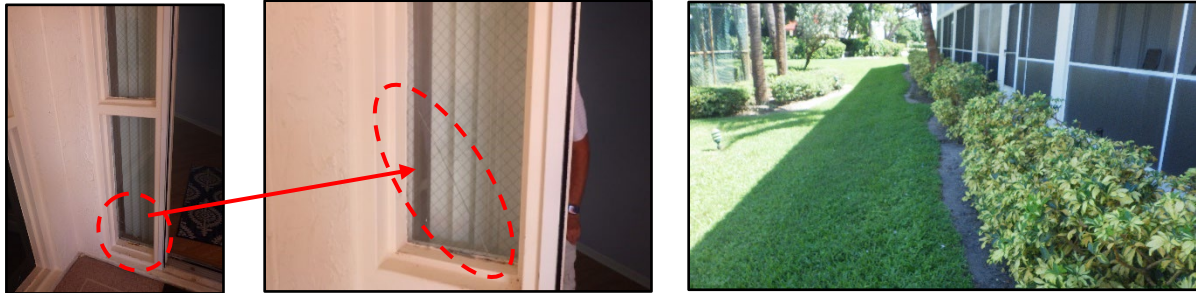
Cracks were observed in several, side-panel windows, at Bldg 103, including at Units A2 & B2. This may be a result of slight twisting/settlement of the building along the west (back) side of the building, which is constructed on a small embankment of fill material. No other concerning cracks or separations were in the area and the condition is not expected to significantly worsen.
