Mandatory Structural Inspection (Milestone) Report

Phase 1 Milestone Study Per Florida Statute 553.899 (SB 154)
Half Moon Condominium Association, Inc. (KHOV – Low Rise Buildings)
7070 Half Moon Circle, Hypoluxo, FL 33462

July 9, 2024

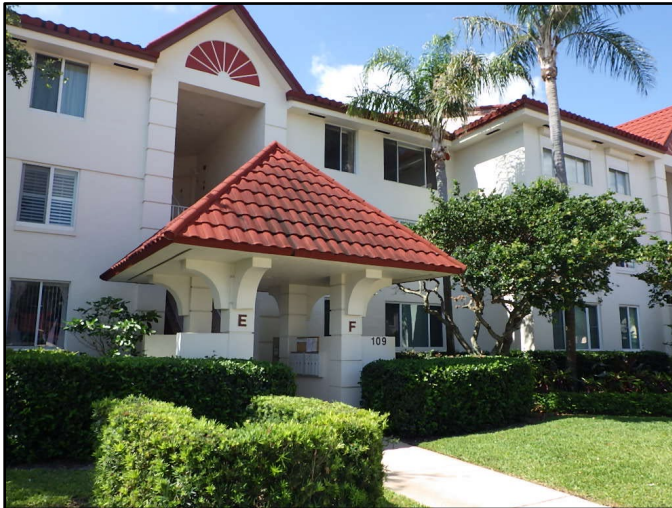
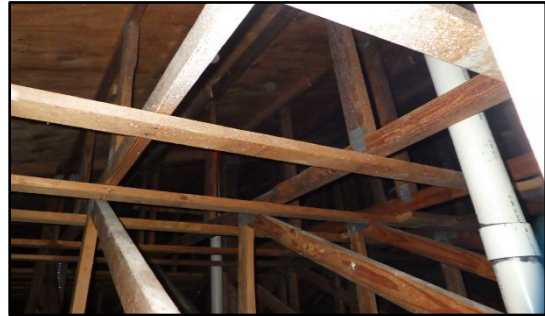
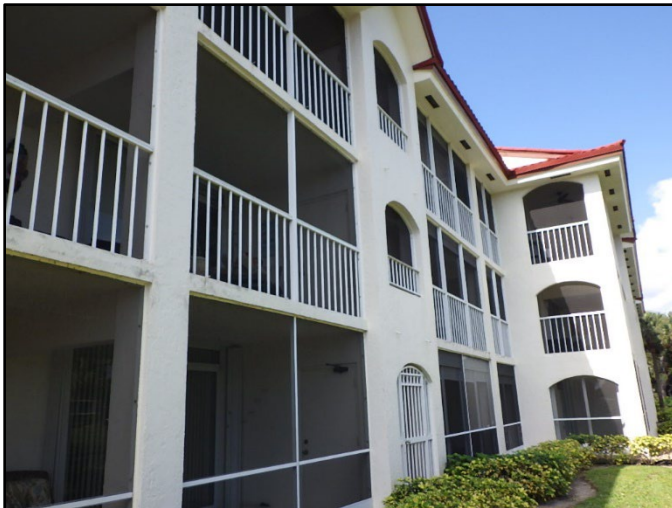
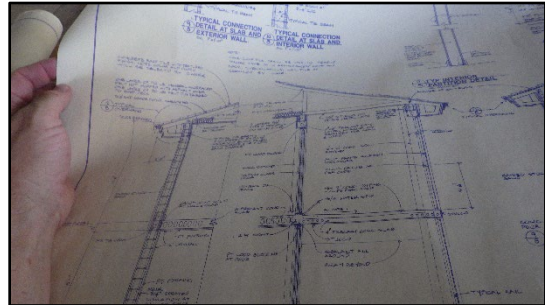
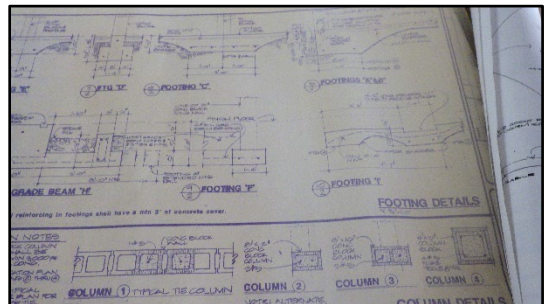
The buildings were observed to be in good condition, with no indication of substantial distress to the primary structural system. Several issues are further discussed below.

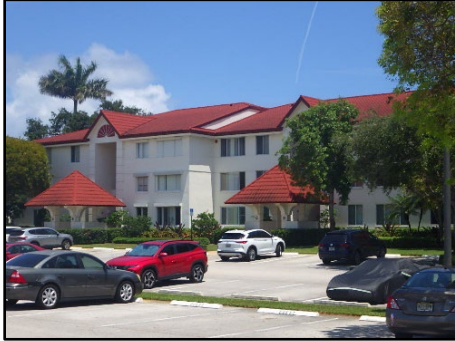
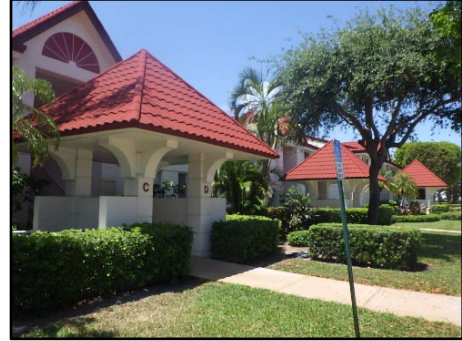
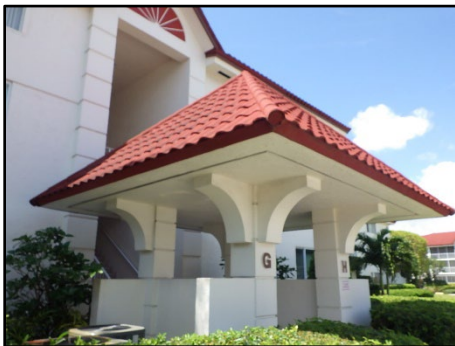
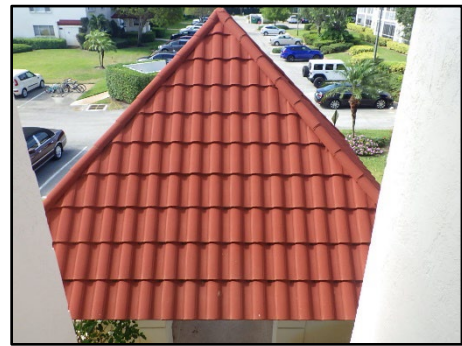
ground-level, stairways and elevated walkways. No missing, misaligned, lifted or other damage was observed to any roof tiles on the observed buildings. Routine yearly inspections and inspections after storms are recommended.
