Half Moon Bay by K-Hov C.A.
SIRS Components
Hypoluxo, FL

Report #: 51276-0
Beginning: January 1, 2025
Expires: December 31, 2025

RESERVE STUDY
"Full"

October 24, 2024

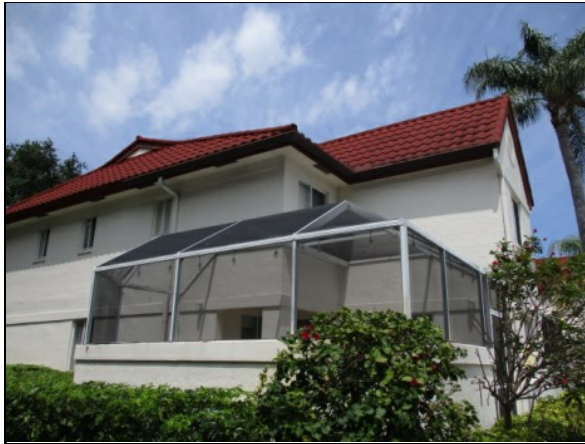
Comp #: 2384 Roofing (Metal) - Replace

History: Replaced in 2007 (per information provided)

Useful Life:
30 years

Remaining Life:
12 years

# Component	Useful Life (yrs)	Rem. Useful Life (yrs)	Current Average Cost
A. Roof			
2384 Roofing (Metal) - Replace	30	12	\$2,620,000
B. Structure			
2341 Building Exteriors - 2026 Project	0	1	\$36,300
2341 Building Exteriors - Future	7	8	\$103,000
2341 Walkway Repairs - 2025 Project	0	0	\$16,000
